Inspection Report

Minerals Regulatory Program

Mine Name: Daddy Dearest 1-9/Blackhawk
Operator or Permittee Name:
Thomas J. Clark and Company
Permittee Mailing Address:
1145 North 1100 West, St. George, UT 84770

Permit number: S/015/046
Inspection Date: July 2, 2004

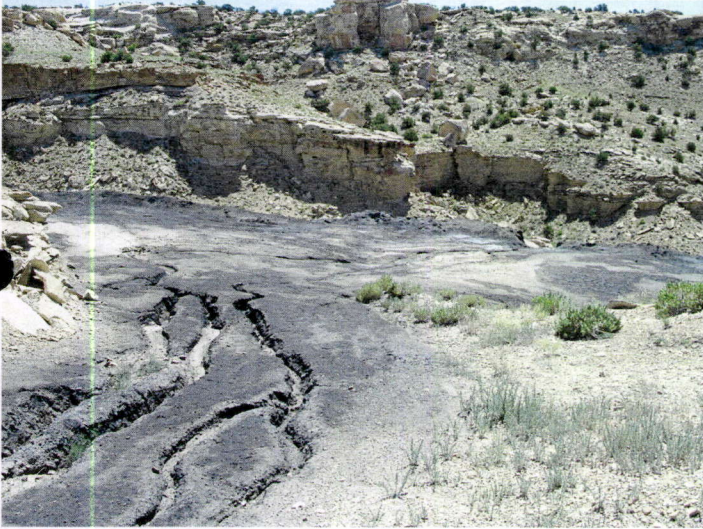
The area appears to have had a substantial amount of rain this year. Photos 1 and 2 show an area just north of the portals where water has gathered on the pad, breached the berm, and flowed down the outslope. The gully in Photo 2 is about four feet deep where it goes over the edge.

Photo 1. Erosion patterns on the pad leading to the gully shown in Photo 2.

Two possible options for repairing this problem are:

1. Build the berm back up, slope the pad away from the edge, and keep all the water on the pad.
2. Install a silt fence where the water goes over the edge. This silt fence would need physical reinforcement with welded wire, and it should also be notched to allow water to flow out the top while retaining sediment.

Either of these methods would require some continuing maintenance.

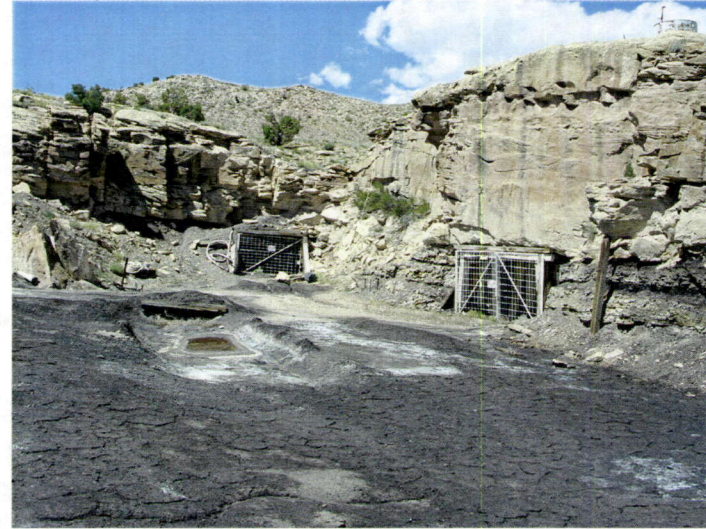
Photo 3. The portals.

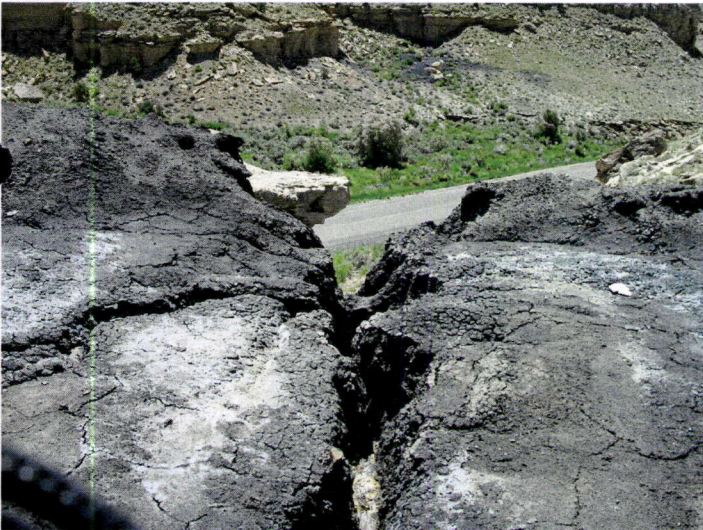
Photo 2. This is where water drops off the pad. This gully is about four feet deep at the edge.

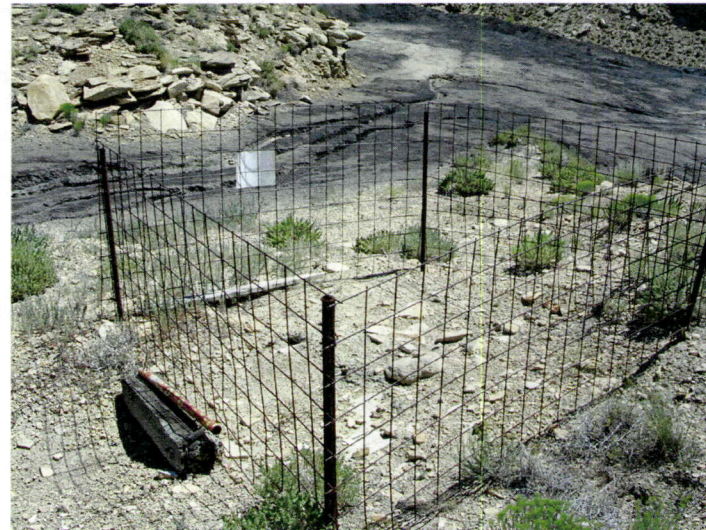
Photo 4. This is a shaft that was covered with boards and some dirt.
